**Subject: Annual Inspection Report
Addison Municipal Airport**

ANNUAL INSPECTION REPORT

ADDISON MUNICIPAL AIRPORT

ADDISON, ALABAMA

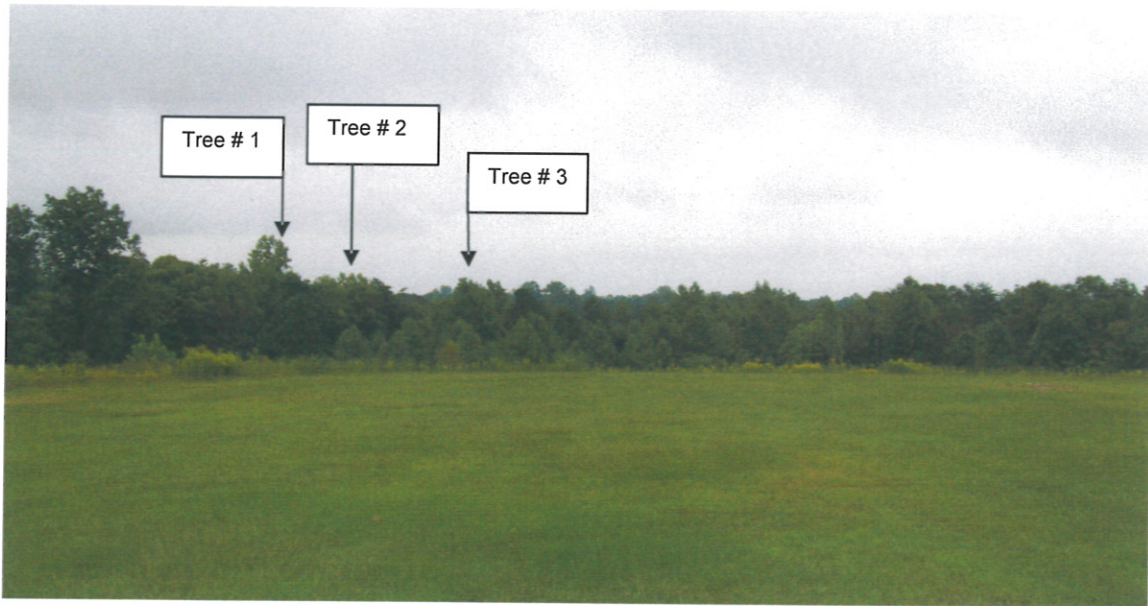
Photo # 1 – Runway 22

- Runway 22: Trees identified as Tree # 1, Tree # 2, and Tree # 3 violate the ALDOT 20:1 Approach Departure Path (See Photo # 1 and Appendix 2).
- Runway 4: No obstructions, but Tree # 6 could become a hazard if allowed to continue to grow into the Approach/Departure Path (See Photo # 2 and Appendix 3).

- While these trees are representative of obstructions in the approach departure path of runway 22, they do not include all the trees that may violate the 20:1 approach departure path.
- In order for an operating license to be issued the obstructions to runway 22 must be removed to provide a clear 20:1 approach/departure path.

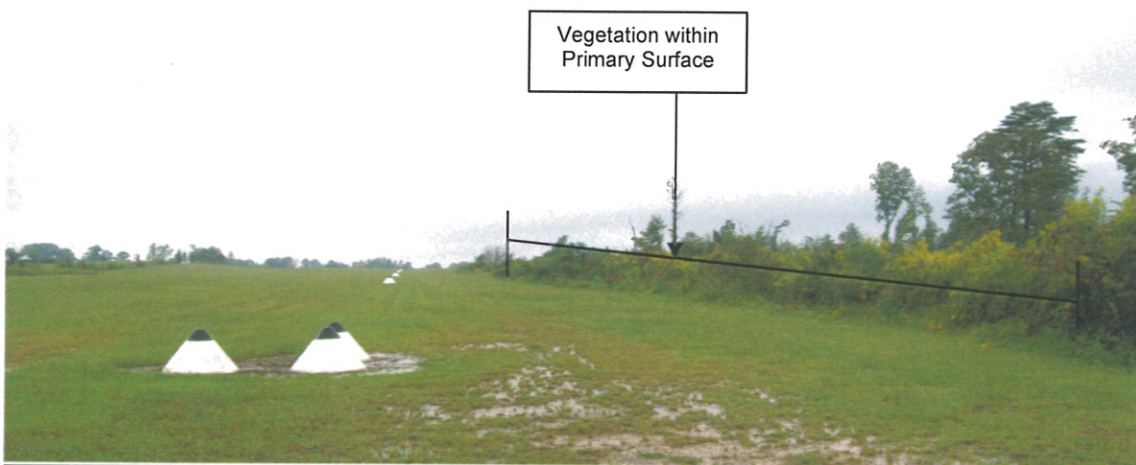
Photo # 3 – Primary Surface

- The primary surface was inspected and brush and vegetation was found growing within its boundaries on northwest side of runway 22 (See Photo # 3 and Appendix 2)

- Brush and vegetation must be removed from primary surface.

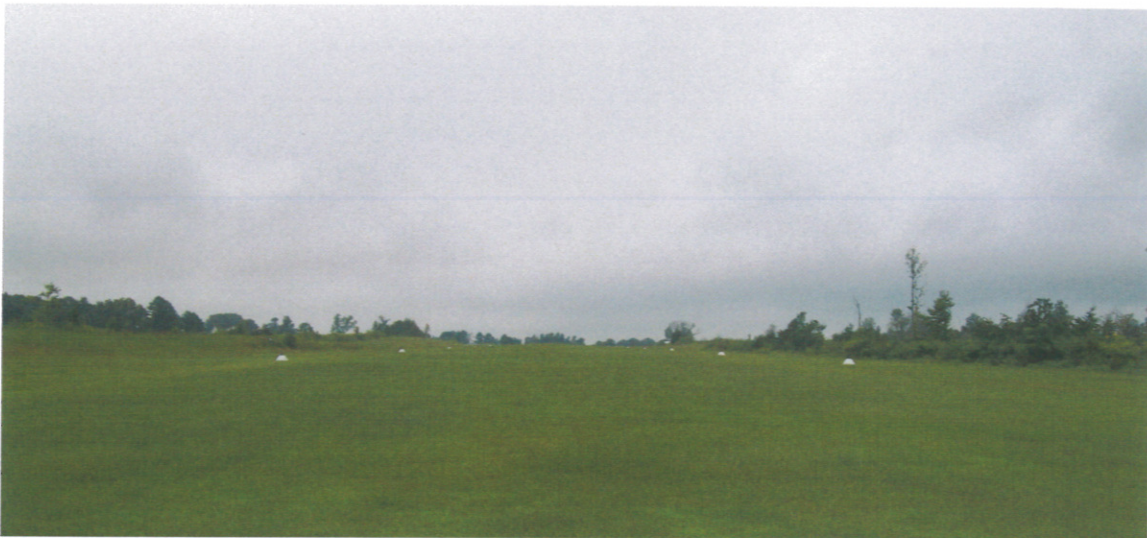
Photo # 4 – Runway 22

- The runway markings are marked with white cones with black tips and are in good condition (Photo # 4).

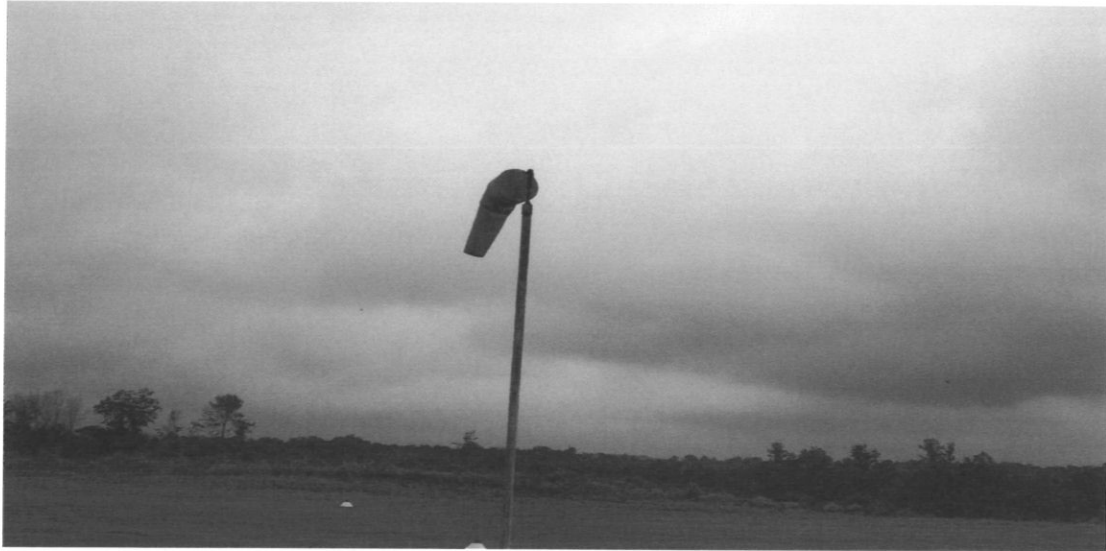
Photo # 5 – Windsock

- The wind direction indicator (windsock) was inspected and found operational (Photo # 5).

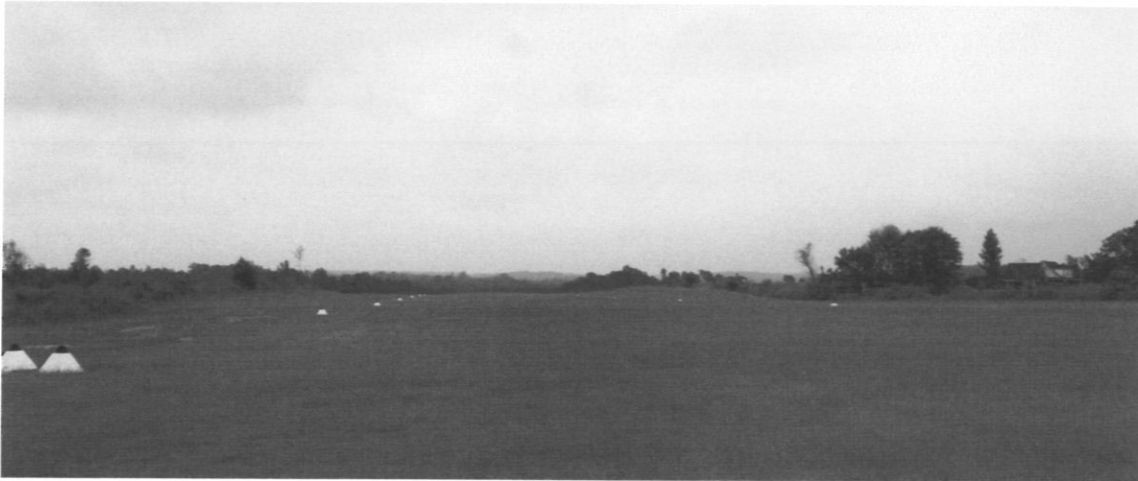
Photo # 6 – Runway Surface

- The overall condition of the runway surface was found to be in good condition (Photo # 6).

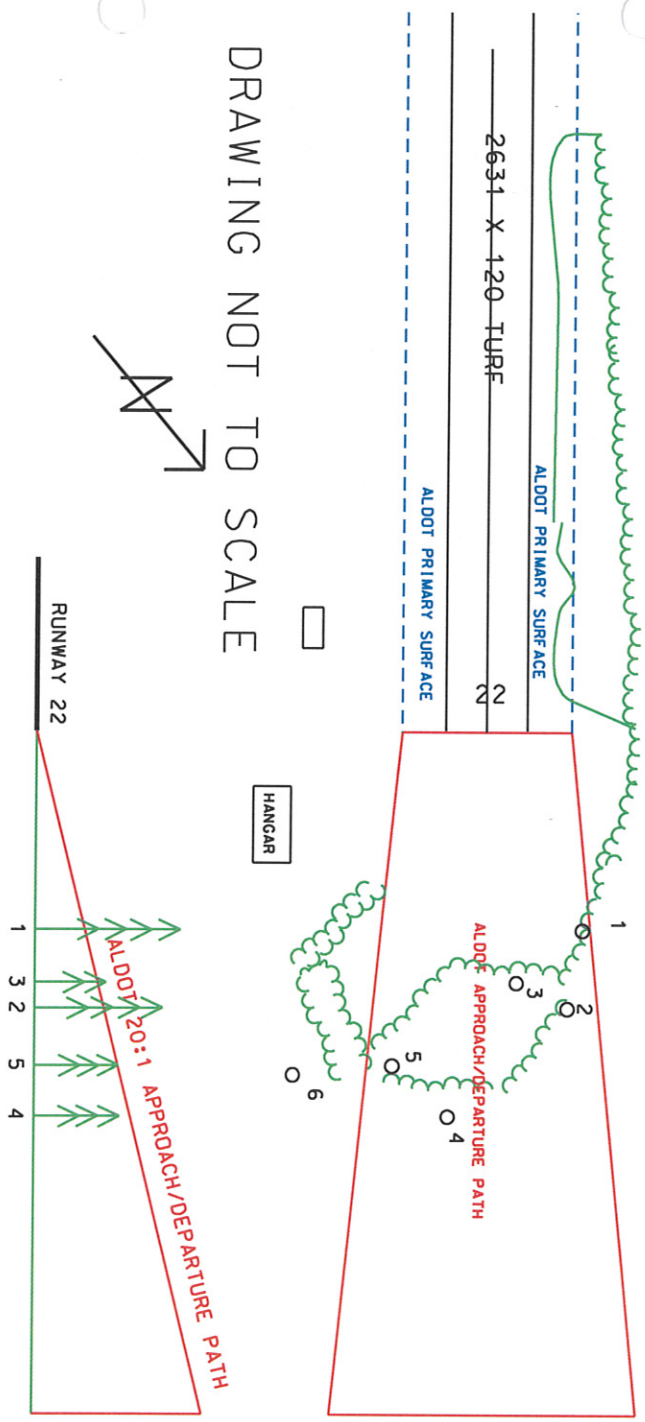
REQUIREMENTS FOR STATE AIRPORT LICENSE RUNWAY 22

1. TREE - 42' ABOVE RUNWAY END
303' FROM RUNWAY END
143' RIGHT OF CENTERLINE
7:1 OBSTRUCTION CLEARANCE SLOPE
2. TREE - 37' ABOVE RUNWAY END
411' FROM RUNWAY END
121' RIGHT OF CENTERLINE
11:1 OBSTRUCTION CLEARANCE SLOPE
3. TREE - 20.6' ABOVE RUNWAY END
369' FROM RUNWAY END
46' RIGHT OF CENTERLINE
17:1 OBSTRUCTION CLEARANCE SLOPE
4. TREE - 24' ABOVE RUNWAY END
576' FROM RUNWAY END
54' LEFT OF CENTERLINE
23:1 OBSTRUCTION CLEARANCE SLOPE
5. TREE - 24.7' ABOVE RUNWAY END
528' FROM RUNWAY END
136' LEFT OF CENTERLINE
21:1 OBSTRUCTION CLEARANCE SLOPE
